### Inspection Report

#### Minerals Regulatory Program

**Mine Name:** Lisbon Valley Project

**Permit number:** M/037/088

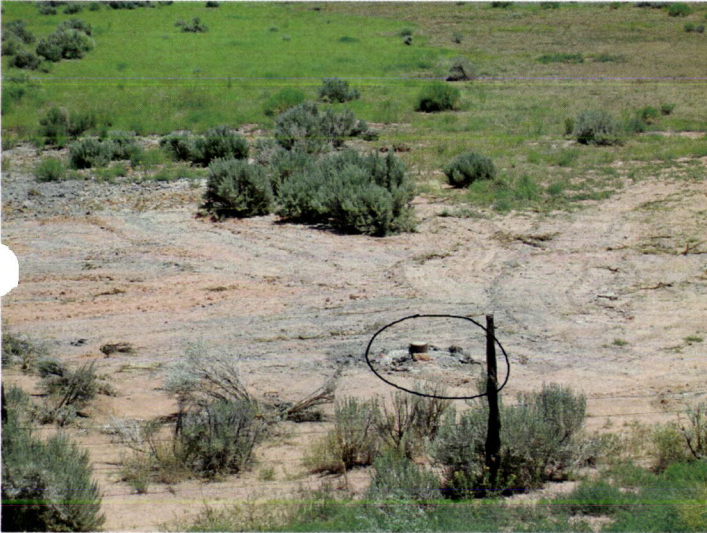
I examined all of the sites that were permitted in December 2003 and drilled this past spring. Of these, one hole has been completed as a well (Photo 1), and one hole (94G-4) has not been plugged, but the rest have been plugged as far as I can tell.

**Photo 1. Drill hole near the reclaimed Wood Mine that was completed as a water well.**

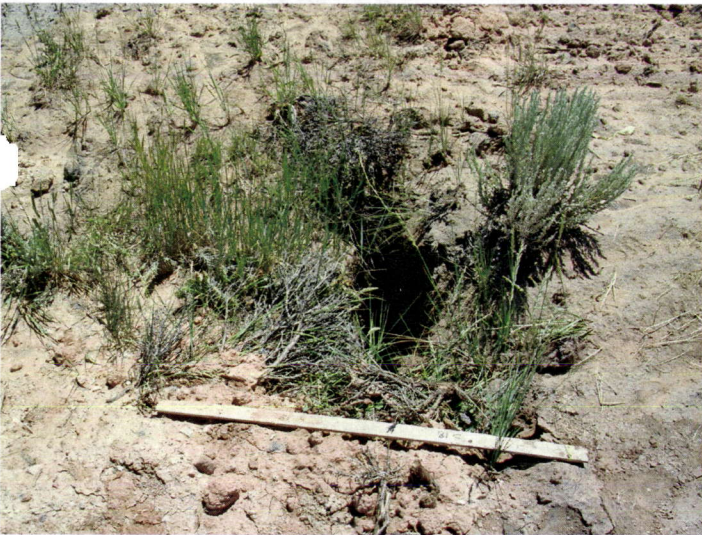
Near 4R-13, I found a hole with a yellow flag and a piece of lathe labeled S18 (Photo 2). This appears to be a drill hole that collapsed, but it does not appear to be the operator's responsibility.

**Photo 2. Hole labeled S18. This hole was not plugged but does not appear to be the operator's responsibility.**

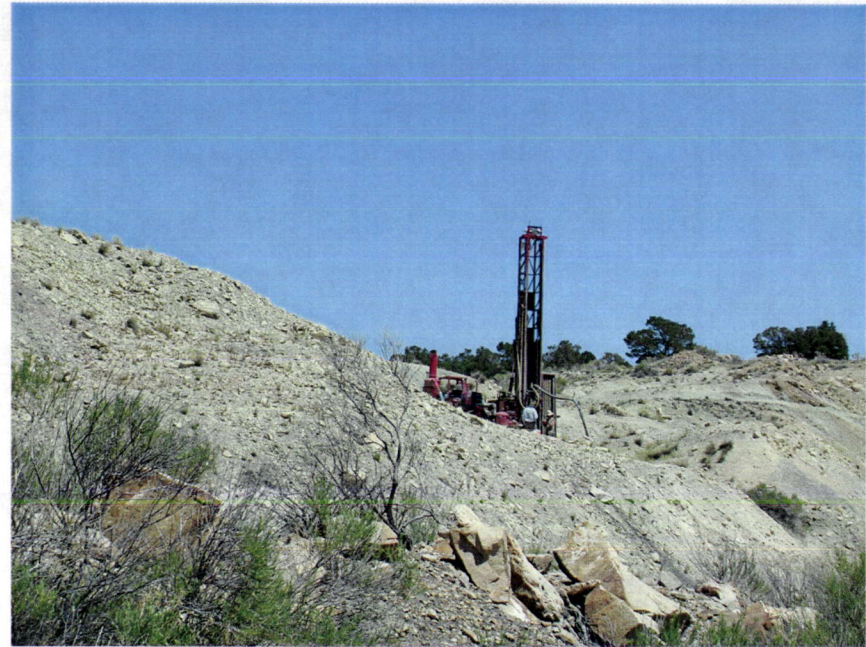
Two drill rigs were in the Centennial Pit at the time of the inspection, but I did not closely examine these operations (Photo 3).

**Photo 3. Drill rig in the Centennial Pit.**
